SCOTT Philharmonic Restoration

In the year 2015, I received a fabulous donation from Dr. Carlos Degrazia. They were "NOS" valves, radio books and several historical receivers. One was the SCOTT Philharmonic, a massive chassis in three parts, heavy and chrome. I had never seen an old receiver of that size, with so many valves and various parts!

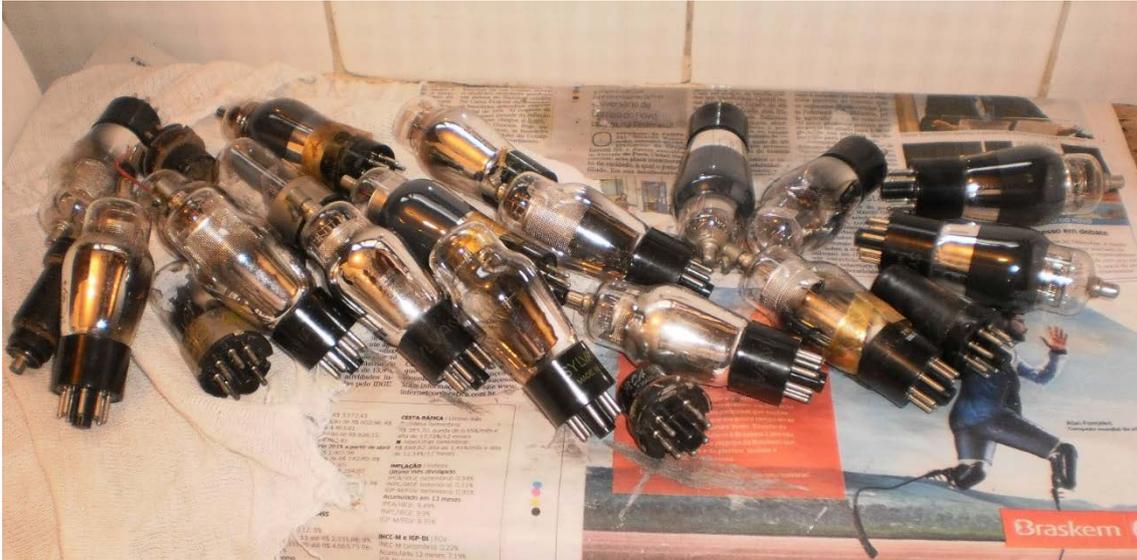
Thankfully, most valves, after testing, showed good emission.

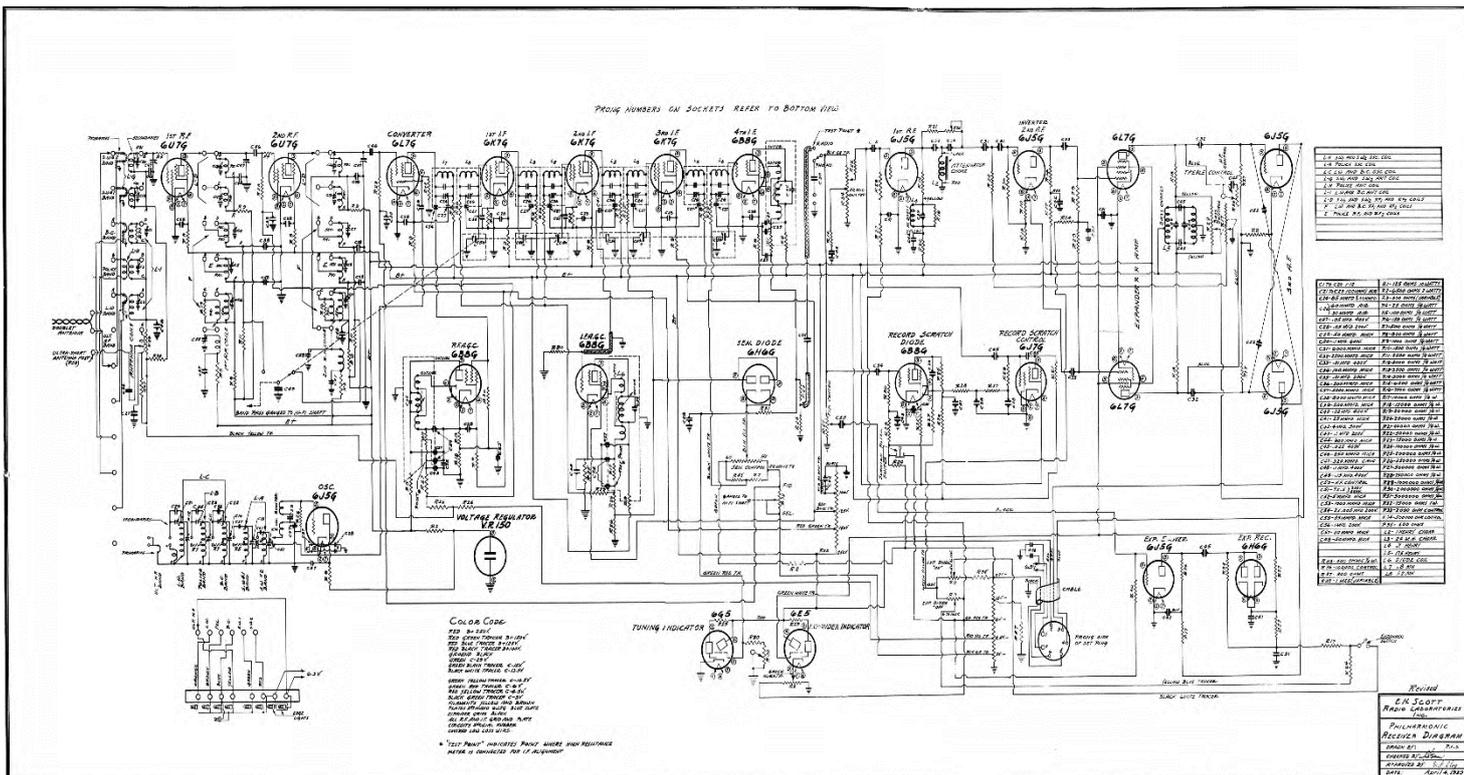
The scheme is as big as badly plotted. Had to be printed on two pages! It can be found at <http://www.nostalgiaair.org/> or at www.radiomuseum.org.

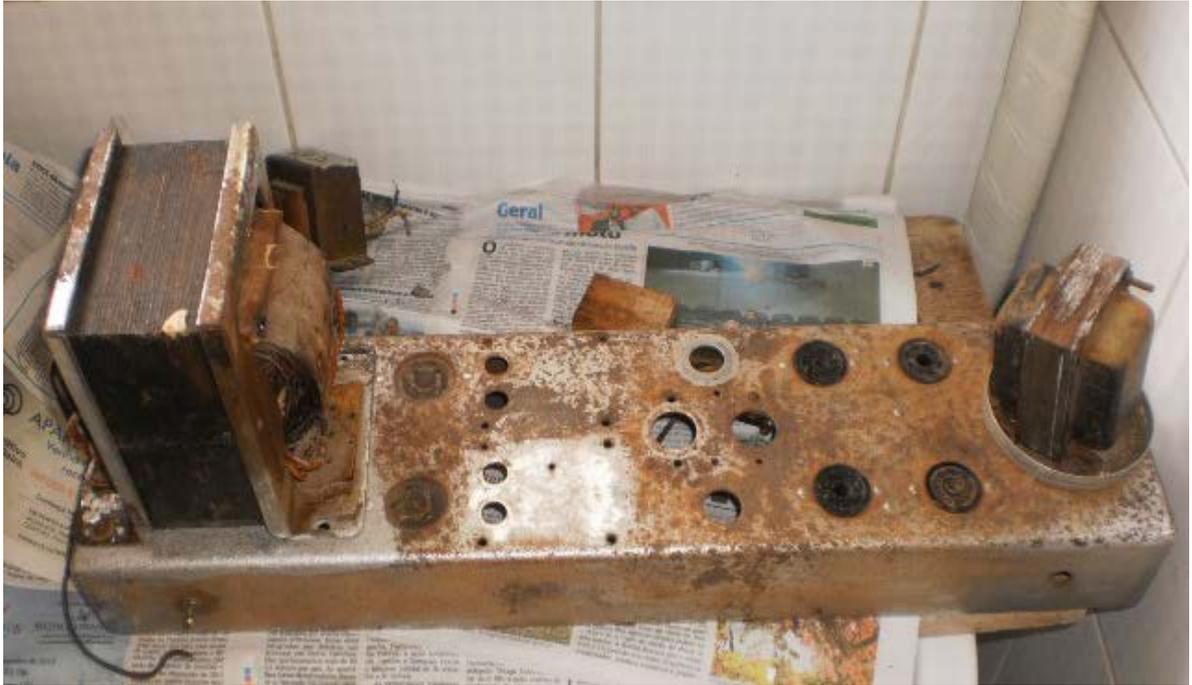
The state of the three chassis received was poor, with some capacitors and other deteriorated components. The original chrome plated in scale and oxidation. There was no dial and the pointer was an "S". He had been kept in a garage for many years.

The rectifying chassis, output with dual push-pull and driver transformer.

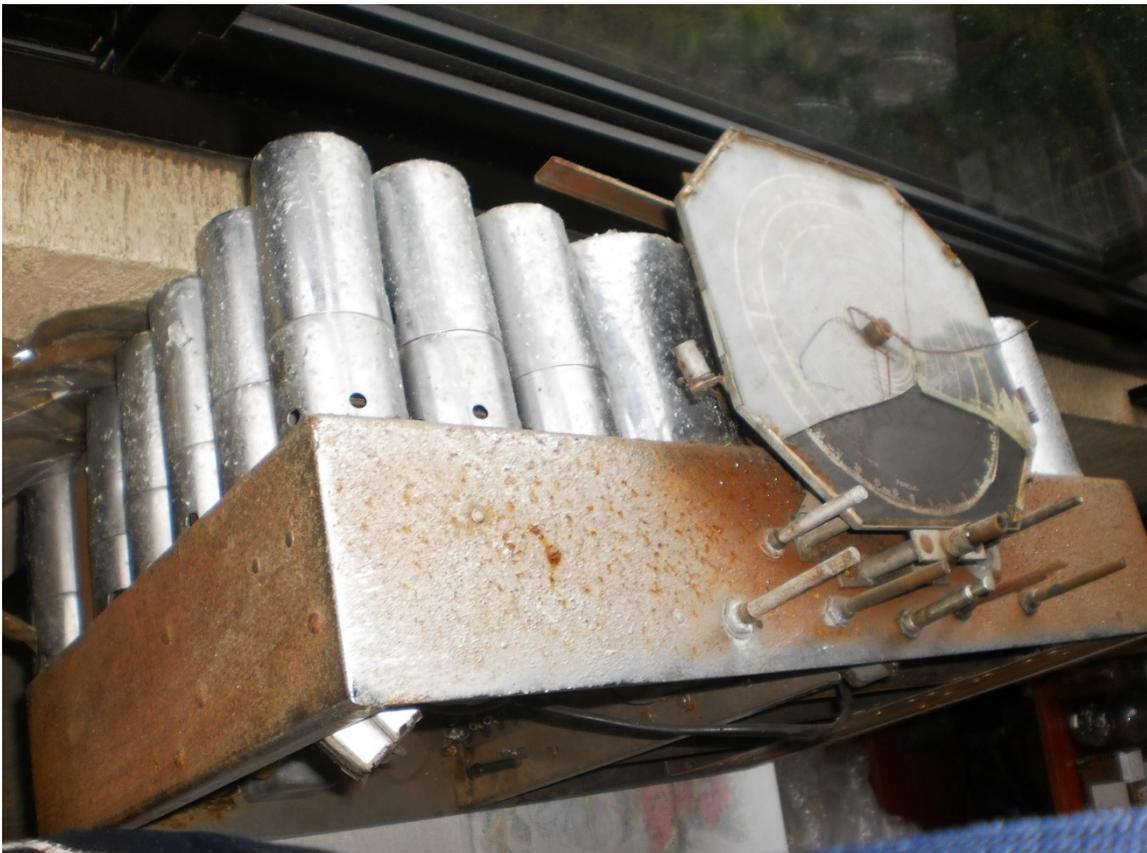
In the photos below, the chassis of radiofrequency, oscillation, FI and audio frequency.

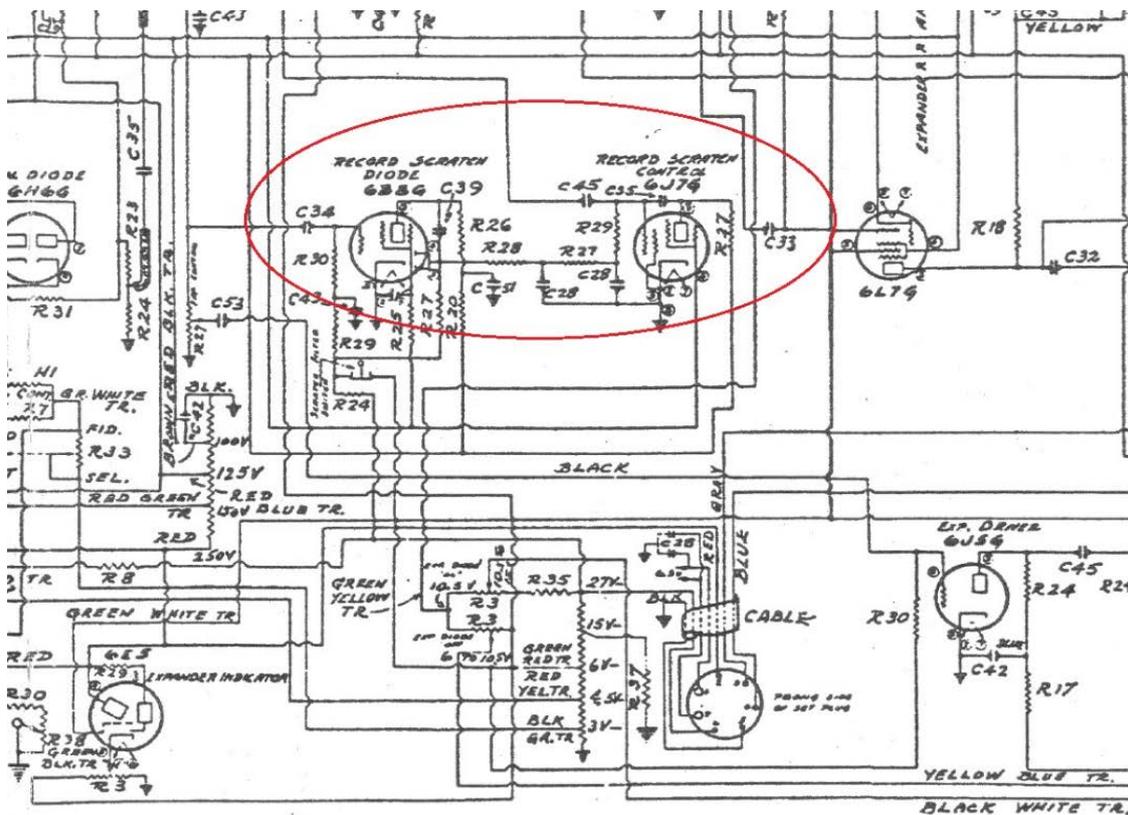
Scratch control and Diode Record Scratch Diode

For example and indicated in the photo above, Norman warned me well that half of the 6H6 valve used as a sensitivity diode was connected to a noise suppressor. This was not demonstrated in the schemes.

I had never worked on a radio with *Scratch*, *Record Diode Scratch*, *RFAGC* (Radio Frequency Automatic Gain Control) or *IFAGC* (Intermediate Frequency Automatic Gain Control). The assistance of EH Scott Radio Enthusiasts (<http://ehscott.ning.com/>) was instrumental in these stages of restoration.

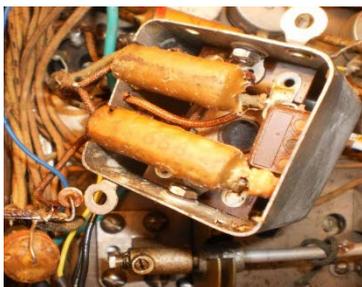
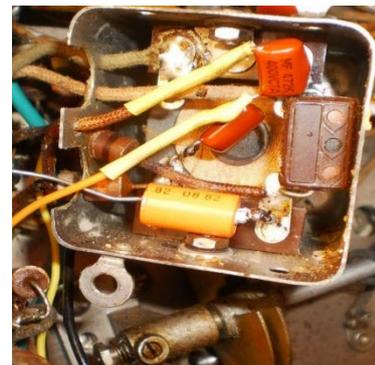
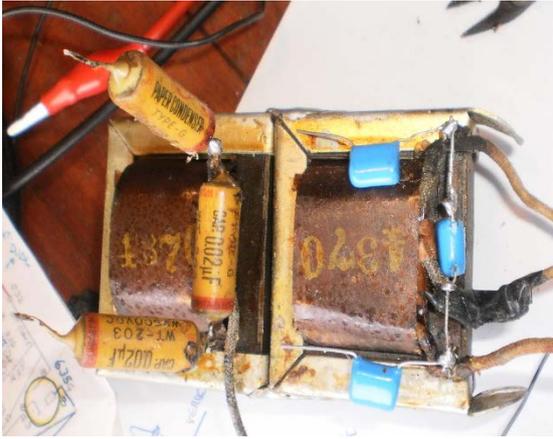
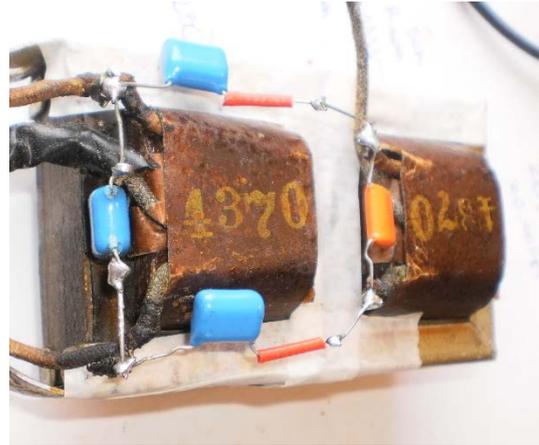
9. Changing critical capacitors

Aside from the electrolytics of the rectifying chassis, I did not count, nor did I remember how many capacitors I had to change. They go from 30.

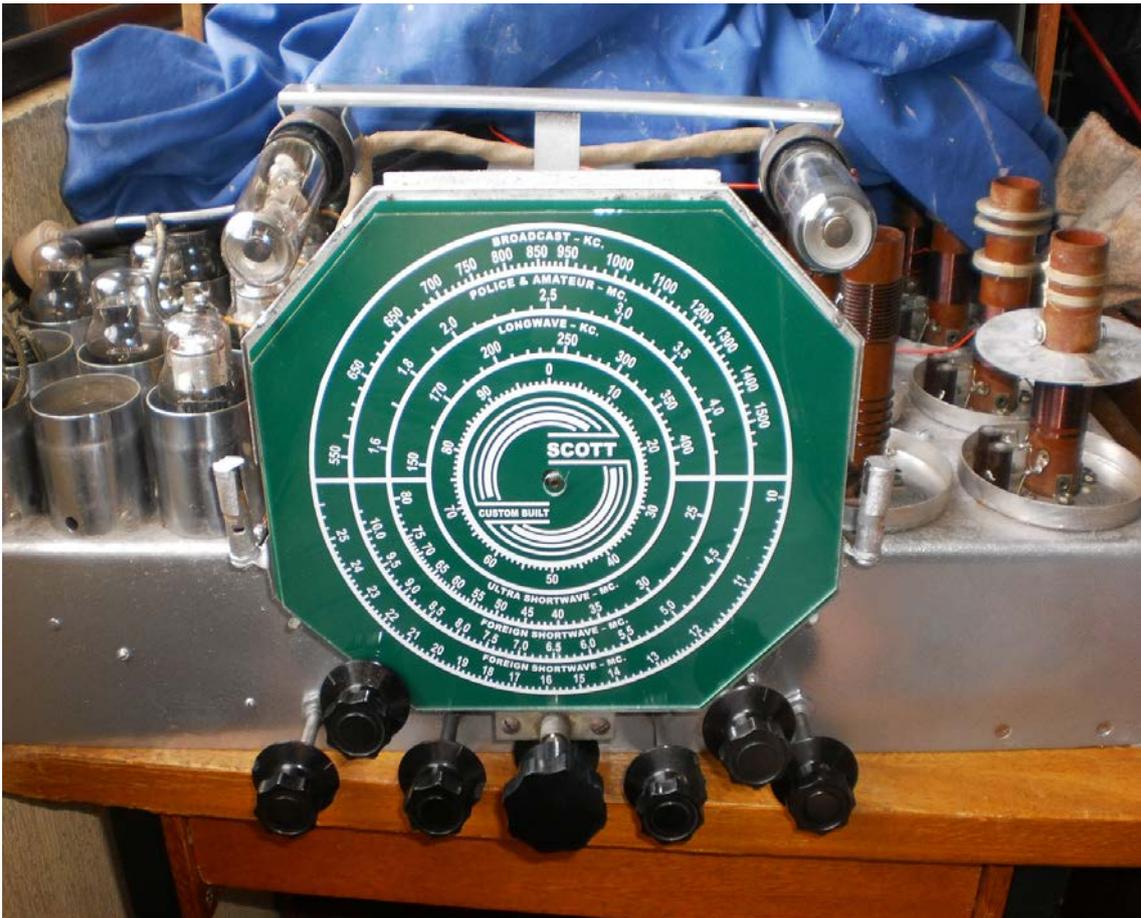
The dial of the Philharmonic, one of the most beautiful I've seen on the radio, was broken (initial photos). With the help of his friend Fabiano Duelli, a new one was made in acrylic. If anyone needs the art, I have it in PDF file.

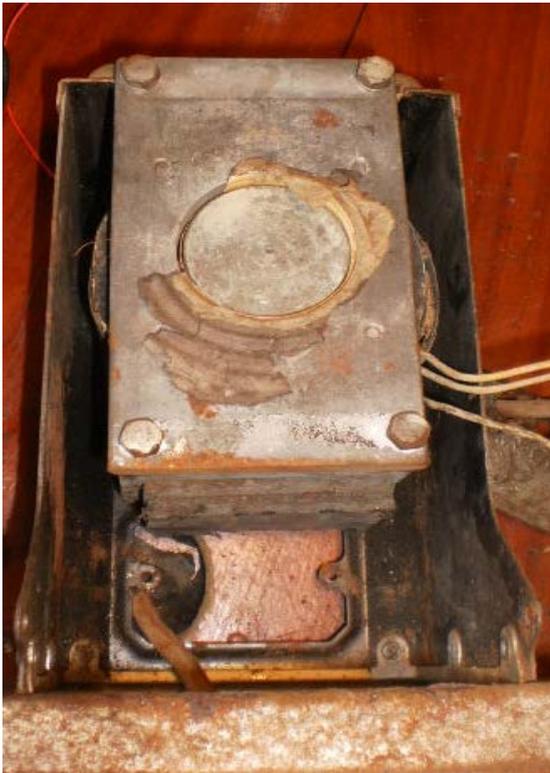
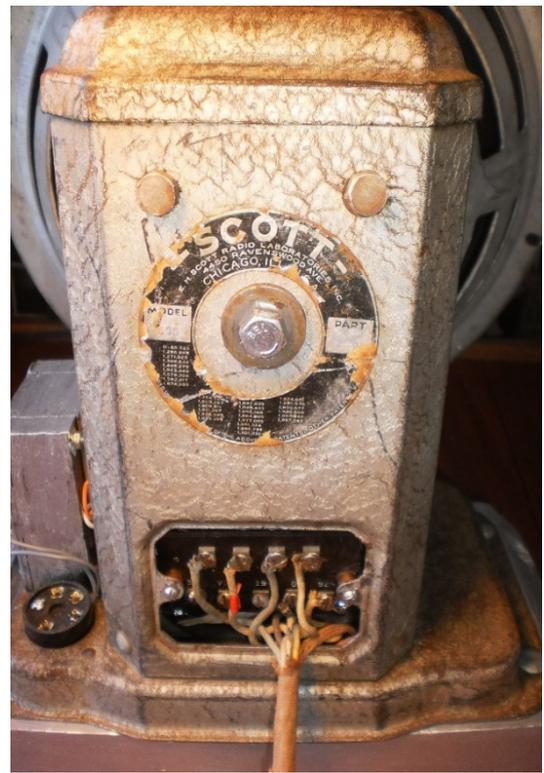
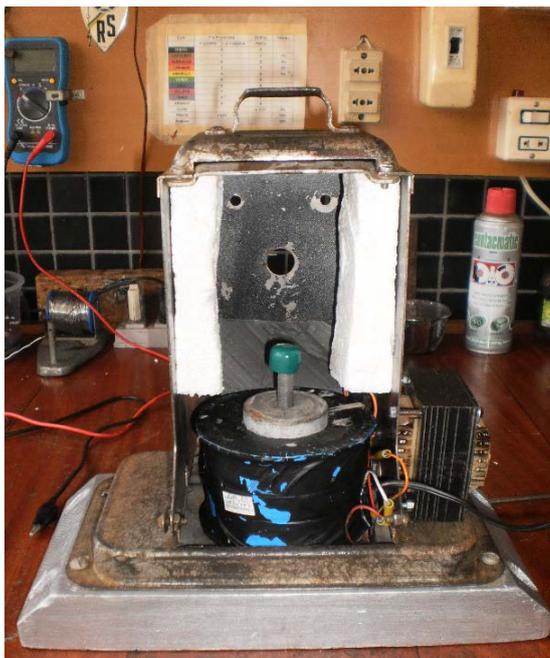
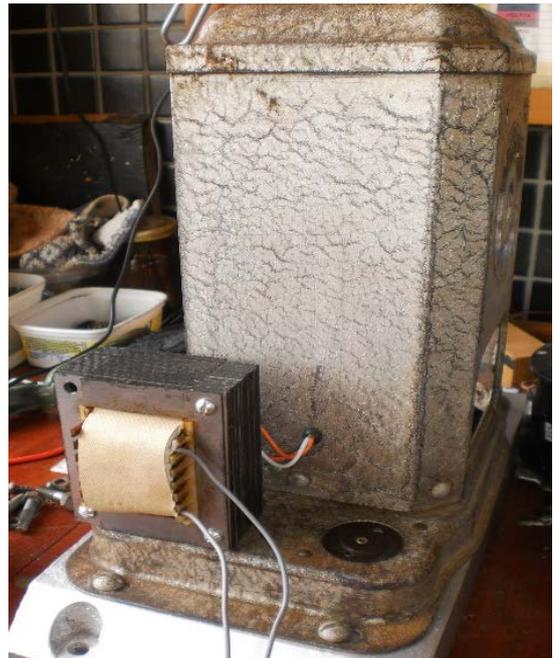
I received the Philharmonic's speaker without the cone. It had been completely destroyed by moths and time. Unfortunately, no AF restorer in Porto Alegre was able to repair the cone while maintaining AF as electrodynamic (without permanent magnet).

The original output transformer was shorted and I had to wrap another. It was put on the outside of the chassis. The photos below explain the situation better.

The solution was to restore the cone as a permanent magnet AF and place the magnetizing coil (the filter shock) next to the output chassis.

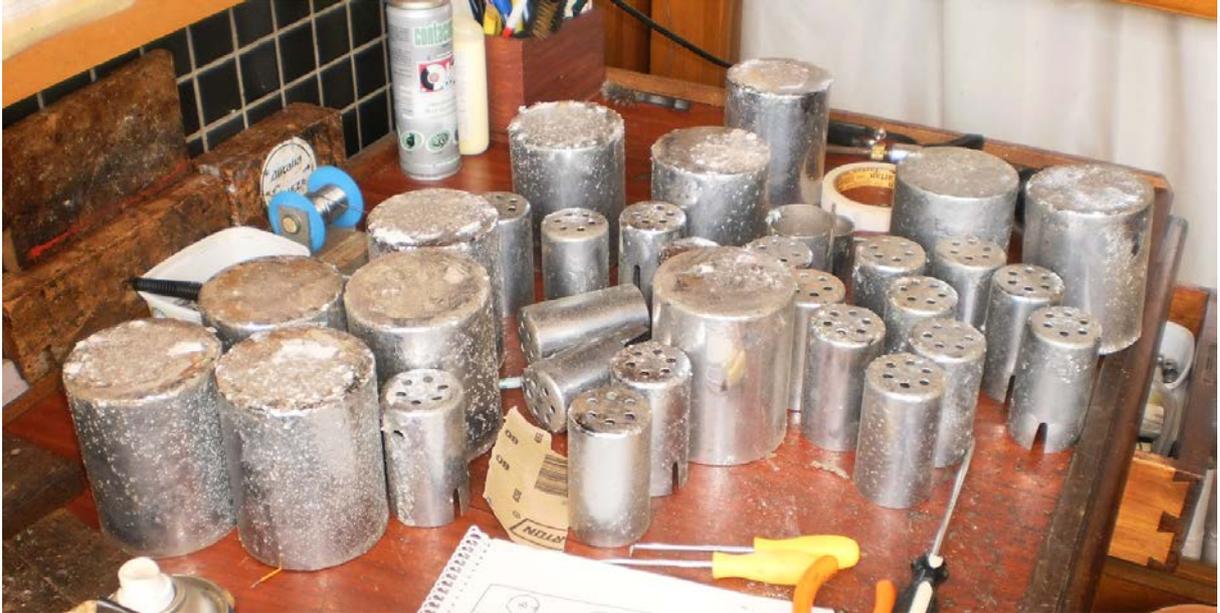
The tradition of this Scott model was chrome chassis. What I received was with the chrome plating completely deteriorated, as can also be seen below in the valves and coils protections.

Chroming these parts and chassis was a time-consuming and time-consuming task. Therefore, I decided to clean the metals with a steel brush, take a shower and paint with spray.

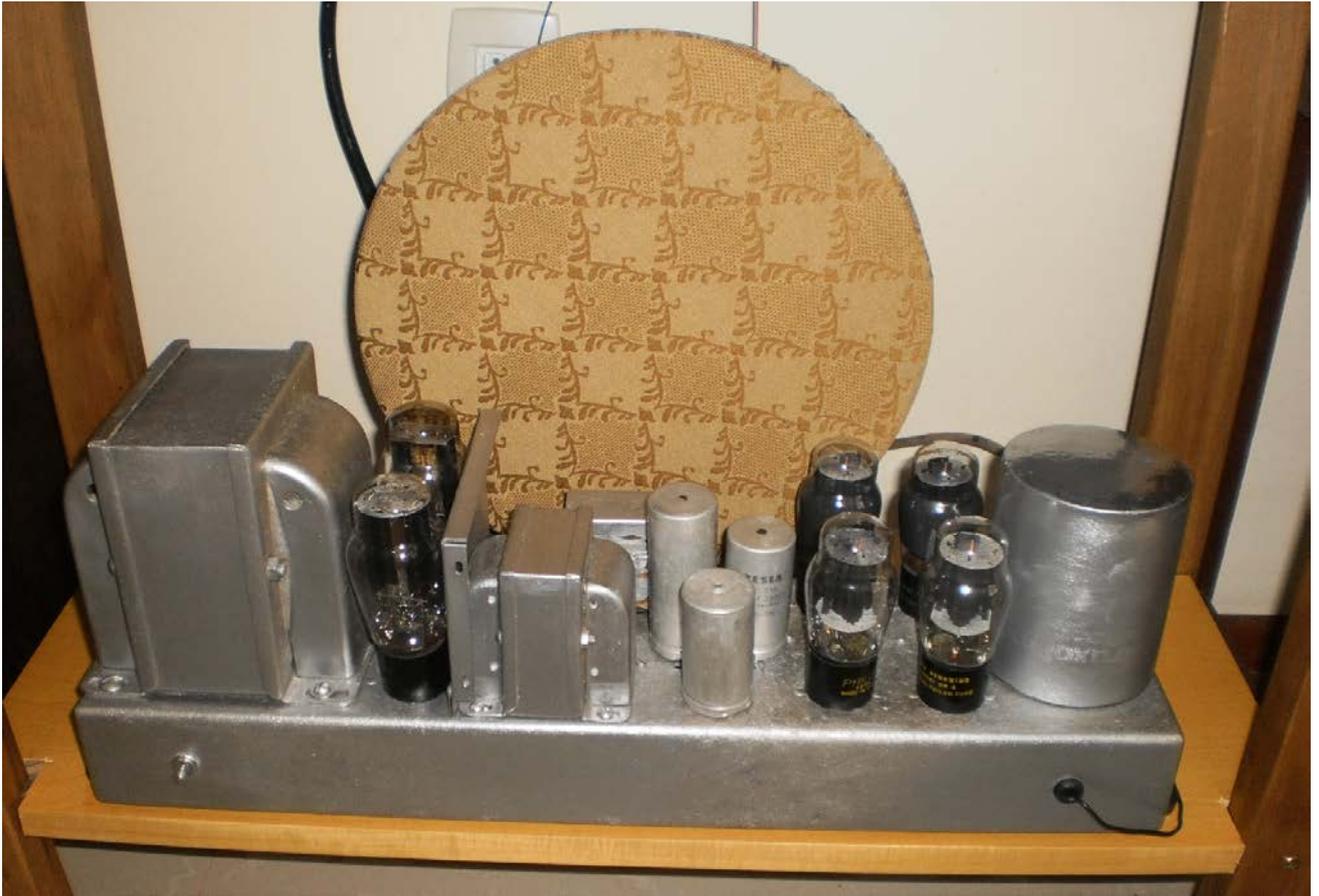
The rectifying chassis. Behind, the speaker set, output transformer and filter shock.

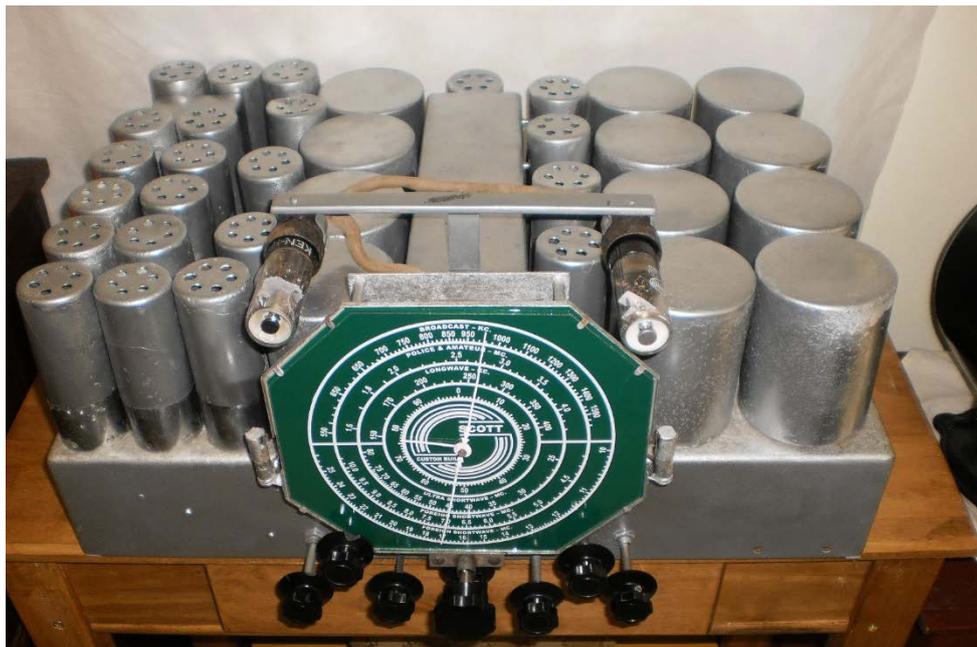
The receiver chassis, ready.
